# ALL SAINTS CHURCH WESTON

## ACCESSIBILITY REPORT NOVEMBER 2018

### Including options for addressing the problems

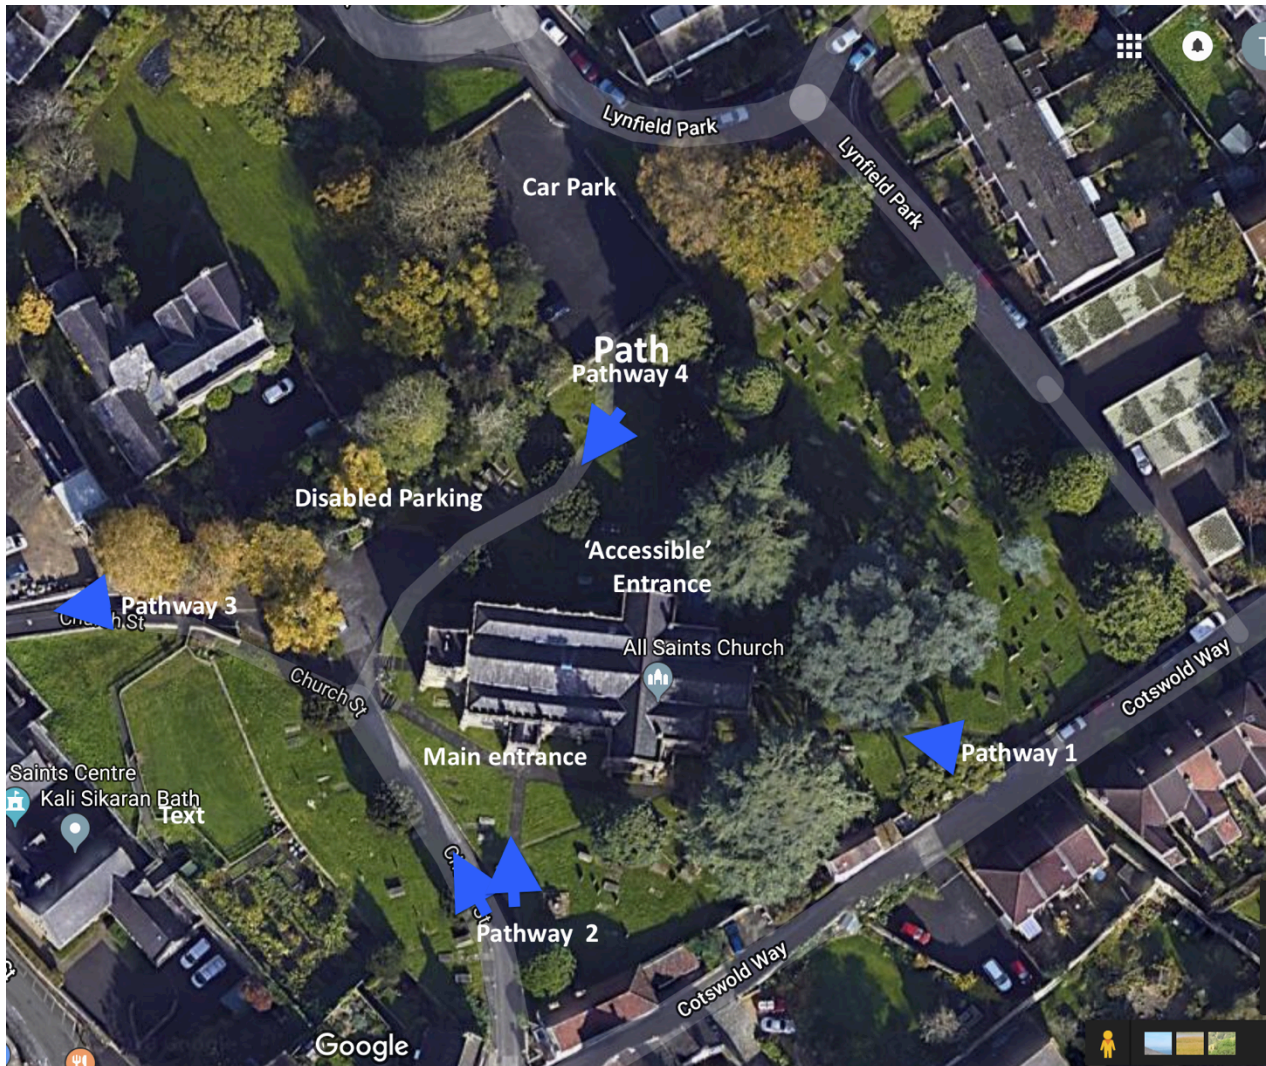
- i. **Pathway 1: Pedestrian path leading from Church Road (Cotswold Way) from the North East:** This pathway across the churchyard has two steps and a fixed bollard at the entrance to the churchyard. The bollard is, no doubt, designed to prevent use by cyclists and motorcyclists, but it also prevents use by people using wheelchairs, walking frames and infant buggies. This path is uneven, although recently improved, and rather narrow. It is restricted to 670mm at one point and is only 700mm usable width for a large part of its length (ie half the width it should be). The gradient is 6.9%, sloping down towards the church building.

- ii. **Pathway 2: Vehicular access 'road' leading from Church Road (Cotswold Way) from the South East:** There is a very steep roadway leading from Church Rd to the Rectory (as well as two other private houses and the disabled parking bays). The direct route to the current main entrance to the church from this roadway means negotiating nine stone steps and some cobblestones. To avoid these steps the road must be followed further up the hill and then by a return to the main entrance.

- iii. **Pathway 3: Pedestrian path (Church Street) from the South West:** There is a very steep pedestrian path from Church St (SW). The path has a rail for most but not all of the steepest part, where the slope is 19.7% (nearly 1 in 5). It is particularly dangerous in wet or icy weather. This brings the user to the west end of the church where there are 6 steps up to the path to the current main entrance in the south porch. If these steps are taken from the west end, there is a

straight path to the south porch, the gradient of which is a maximum of 6.2%. However there is a sideways slope of 7.3%. Alternatively the path to the north, 'accessible' entrance can be taken, but this entrance is far from ideal for other reasons (see later)

- iv. **Pathway 4: Lynfield Park from the North West, where the car park is situated:** There is a pathway leading from the church car park at the end of Lynfield Park. The gradient is 10% at its steepest point. Where it has been repaired, the usable width is 2280mm. However at the bottom end of this path there are 7.1m of unimproved path, where it is very uneven at the edges and has only 1.5m useable width in the middle. The pathway has recently been resurfaced, so it is much less uneven than it was.

- v. **Disabled Parking Bays:** At the bottom of this path, on the north west corner of the church building, the path widens out into the area where there are four parking bays for people with mobility impairments are situated at the west of the building.

- vi. **Pathways leading directly to the church entrances:** There are a number of problems with the pathways leading directly to church entrances:
    - a) From the disabled parking bays, there is a 'ramp' to the paths going around north, west and south sides of the church. These paths lead to the south porch main entrance and the 'accessible' entrance on the north side. The gradient of the ramp to this path is 10.8%.

- b) The width of the path to the south porch main entrance is variable and narrows to 630mm at one point to the west of the tower. Since this path has been resurfaced, it is raised slightly from the grass at the sides and there is no kerb, so if a walking aid or wheel of a rollator frame, wheelchair or infant buggy went over the edge of the path it would tip over quite readily.

- c) The path along the north side of the church building leading to the 'accessible' entrance has a gradient of 6% and a width of 1100mm, restricted to 1000mm at one point. There are no passing places. This means that **even our accessible entrance path does not meet the regulations either in terms of width or gradient – never mind the other pathways.** It is possible for this path to be used by people with walking aids or wheelchairs if they have someone to assist them, and if nobody is coming the other way, but the requirement for making independent access is not met. This path is also insufficiently lit at night and goes past the dustbins. It feels very much like a 'second class' entrance.

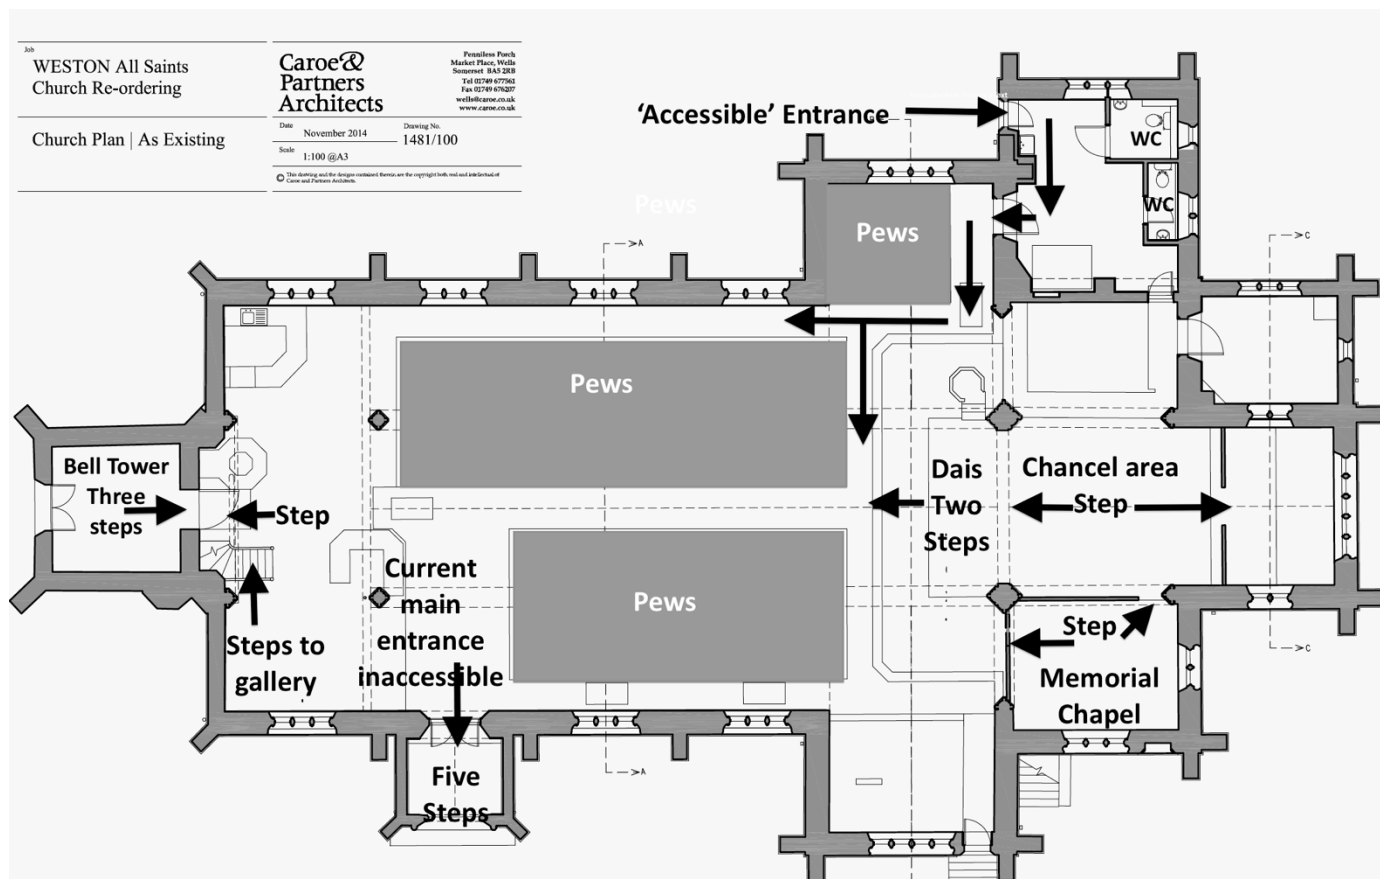
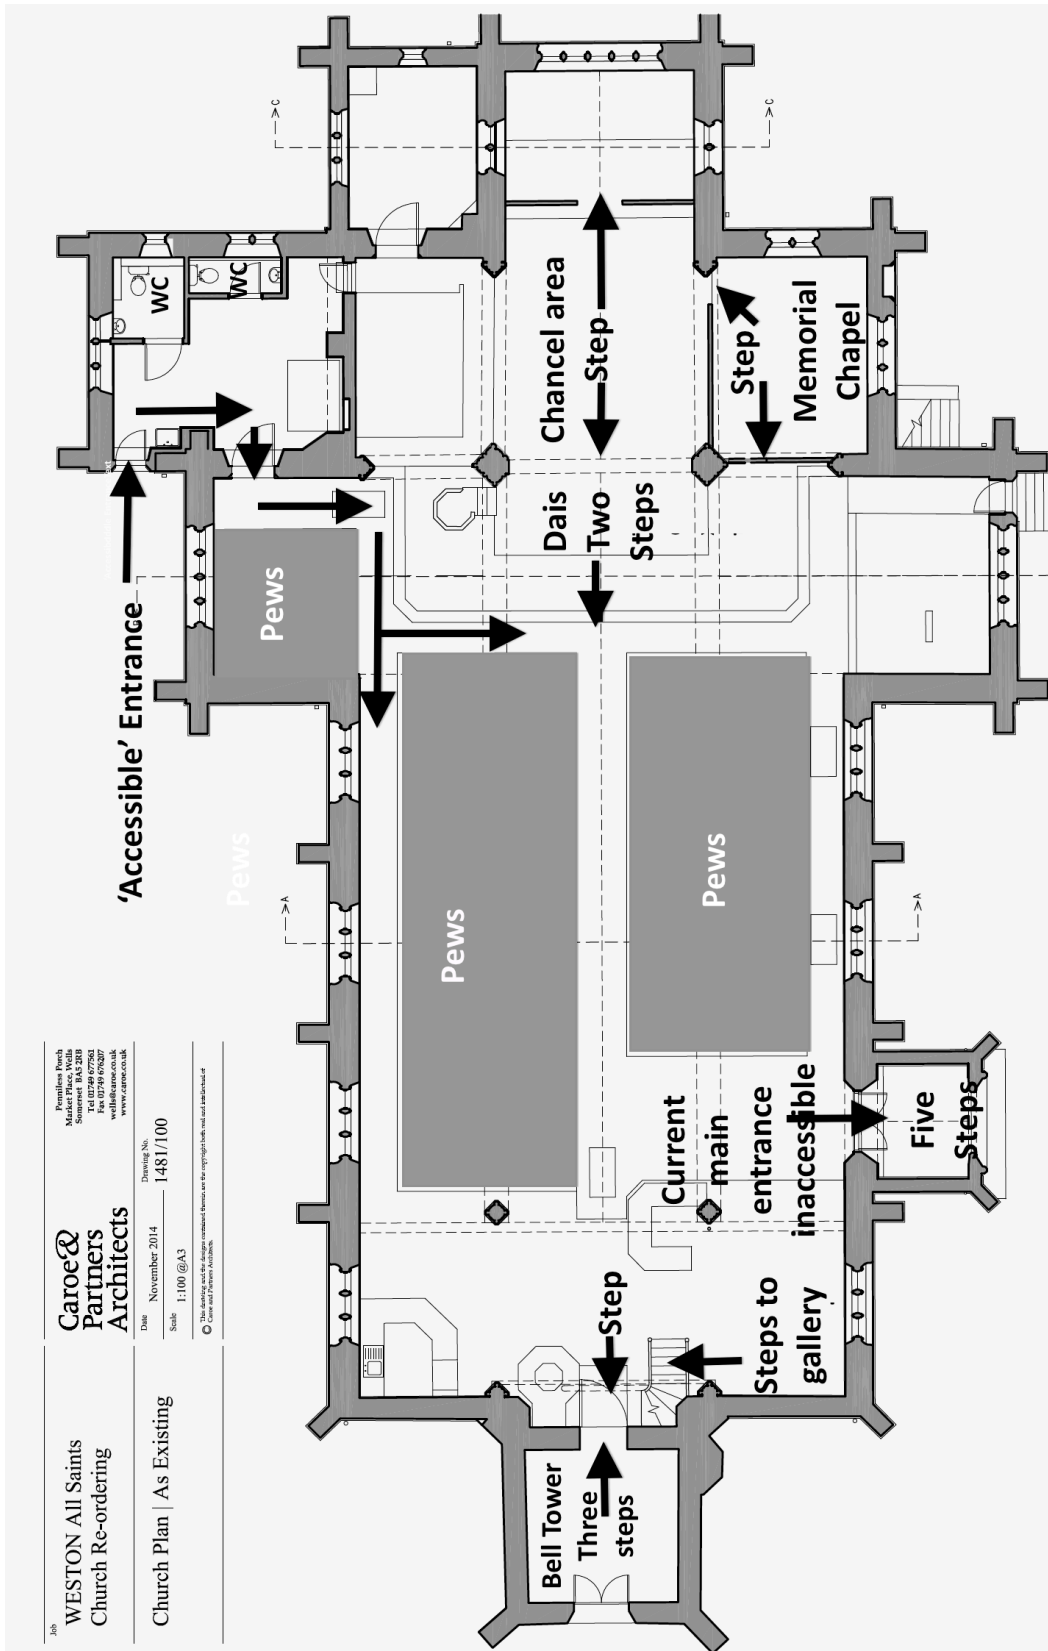
**ACCESS INTO AND AROUND THE MAIN PART OF THE CHURCH BUILDING FROM THE 'ACCESSIBLE' ENTRANCE**

- 13. Circulation Space:** (See diagram above showing internal access from north entrance and for larger version see Appendix 1). Regulations require a minimum of 1200mm width of walkways, with passing places, for wheelchair and mobility aid users. External doors are required to be a minimum of 800mm with 300mm clear space to the side of the doorway. Internal doors can be a minimum, of 750mm with 300mm clear space.

- a. From the north ('accessible') entrance, a 90° turn to the right is necessary, followed by another 90° turn to the right through a second door. Immediately through the second door there is another 90° turn to the left into a 970mm walkway; this turns again 90° to the right but the width of the walkway is only 870mm, which is not enough to turn a wheelchair cleanly. People often abandon walking aids at this point because of the lack of space. It is not possible to enter the church building independently in a wheelchair. An assistant usually needs to hitch and jiggle a wheelchair to get it around the corners. The space between the chancel steps and the front pews is only 690mm.

- b. The north aisle is 890mm, so will accommodate an attendant propelled wheelchair, if it can get around the corners this far. A half pew has been removed half way back, to allow space for a wheelchair to park and an accompanying person to sit, or two wheelchairs on their own. The north aisle has been ramped to the back of the building, where the coffee bar is situated, so that it is possible to access this area with assistance in a wheelchair.

- c. The area to the left (west) of the main entrance and underneath the balcony is at a higher level than the rest of the nave. For this reason there is a step on both sides of the welcome desk. There are also steps going down to the Tower door at the rear of the church building, beside the font, which itself is on a raised platform, creating a step all the way round it. People frequently miss these steps and fall down them or trip on them because they are the same colour carpet as the rest of the floor and are therefore difficult to see, especially for people with bi-focal or varifocal lenses or other visual difficulties. These steps have now been highlighted with white tape on the nosing, which helps to some extent.
